FREMONT UNIFIED SCHOOL DISTRICT

Thornton Middle School Conversion

Quattrocchi Kwok Architects

Sept 26, 2018

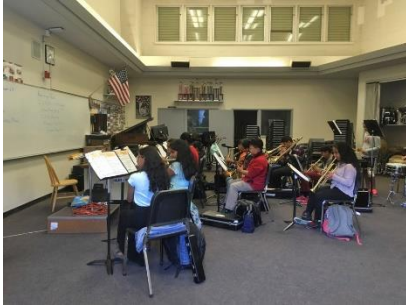
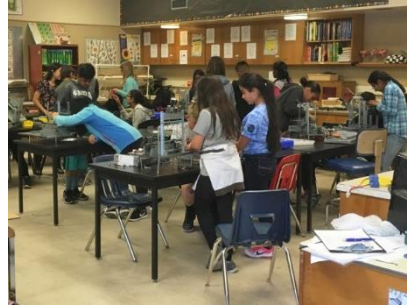
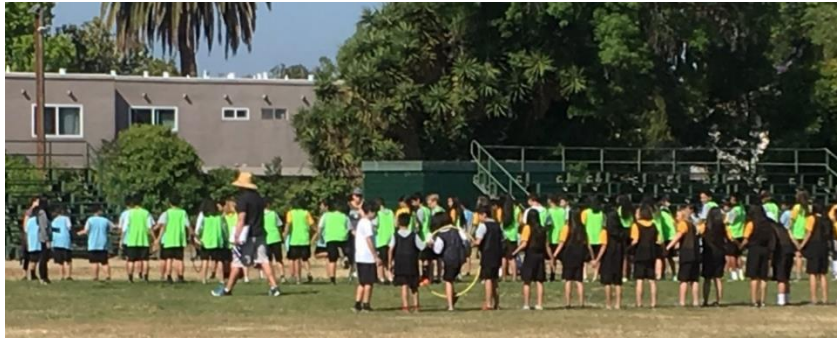
- Incoming 6th graders in year 2021/22
- Student population forecasted to increase from 1,350 to 1,910 by the Long Range Facilities Plan and updated to peak at 2,174 (current long term population trend)
- 2017 implementation plan budget was based on LRFP enrollment of 1,910
- Modernize a 55-year-old campus
- Transform campus and create 21st-century learning environment

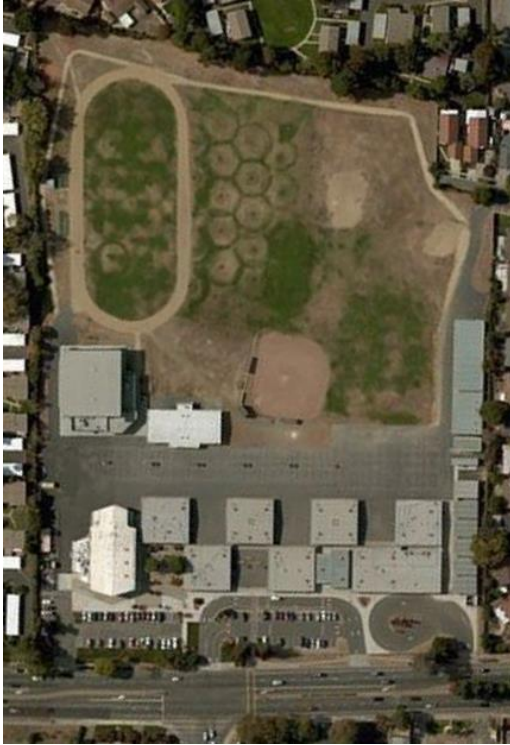
Assessment – Site

- Aged hardscape, almost no landscape, lack of shade
- Lack of outdoor learning & social areas
- Insufficient site lighting
- Sump pump fails, areas flood
- Parking and drop-off inadequate to meet current and future load

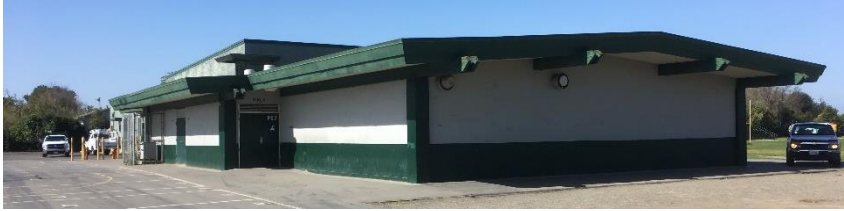
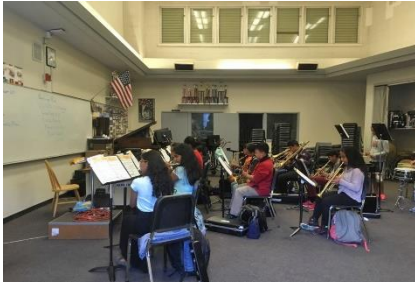
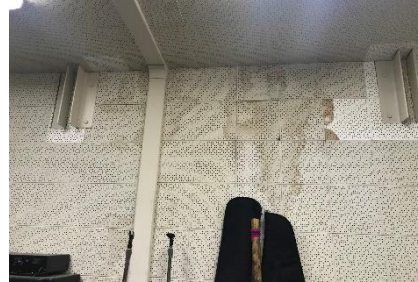
Assessment – Architectural

- Roofing, exterior beams decaying
- Window system, louvers in poor condition
- Deteriorating ceilings, walls, & floors
- Accessibility needs upgrading
- Not enough classrooms for incoming students
- Library, administrative, support services, locker rooms too small

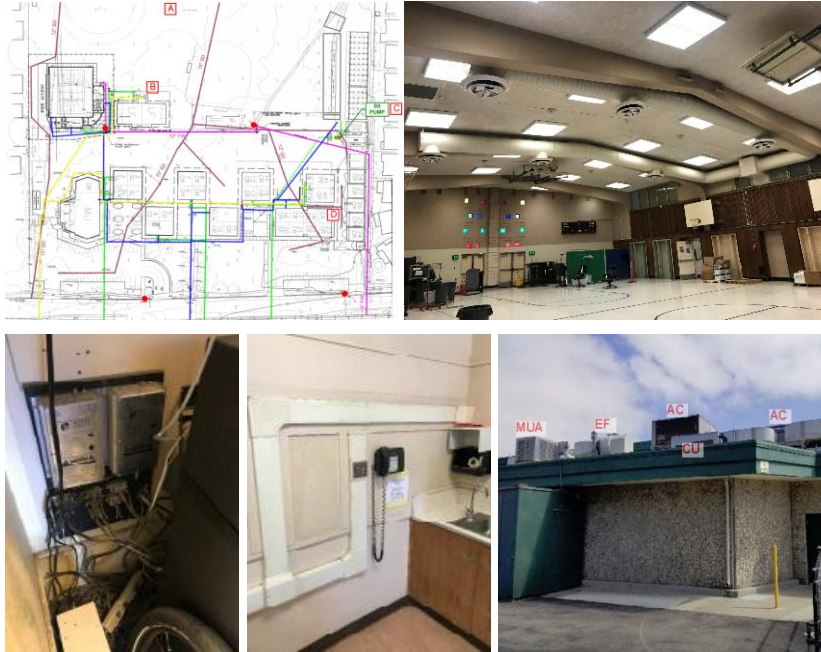
Assessment – Structural & Mechanical, Electrical and Plumbing (MEP) System

- Most mechanical units old & at end of useful life
- Electrical wiring, lighting, & life safety need upgrading
- Campus-wide IT upgrades
- Minimal seismic upgrade of permanent buildings
- Some plumbing fixtures broken or non-compliant

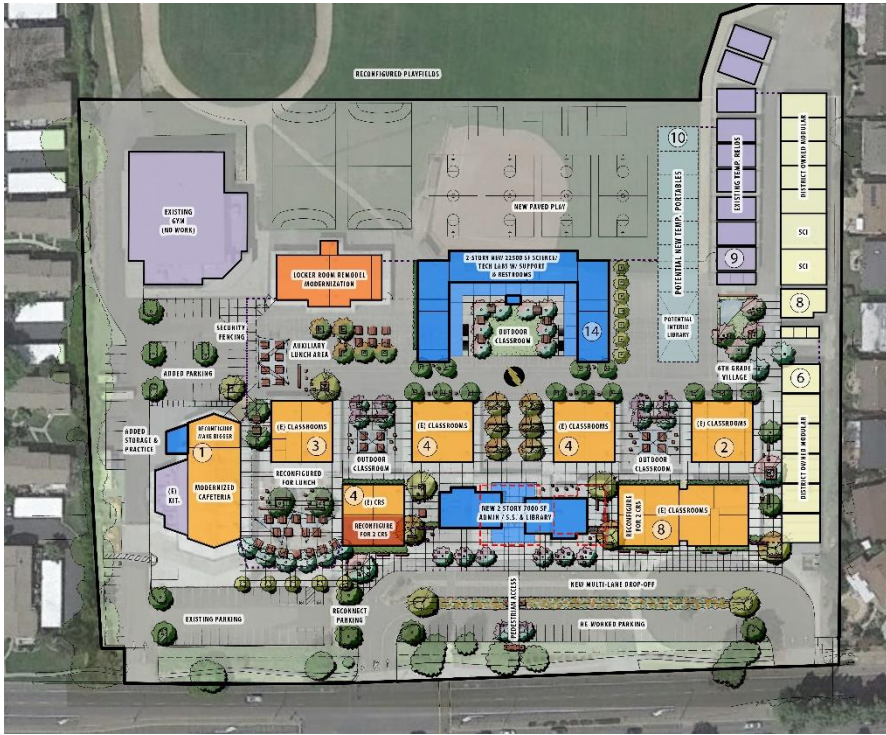
A Transformed Campus

- New identity for Thornton
- Welcoming entry building with library, admin, and student support services
- Improved parking and drop-off
- Modular classroom buildings reduce cost and construction time
- Outdoor shaded area for lunch, study & rainy day physical education (PE).
- Modernize existing buildings
- Ready for 6th graders in fall 2021

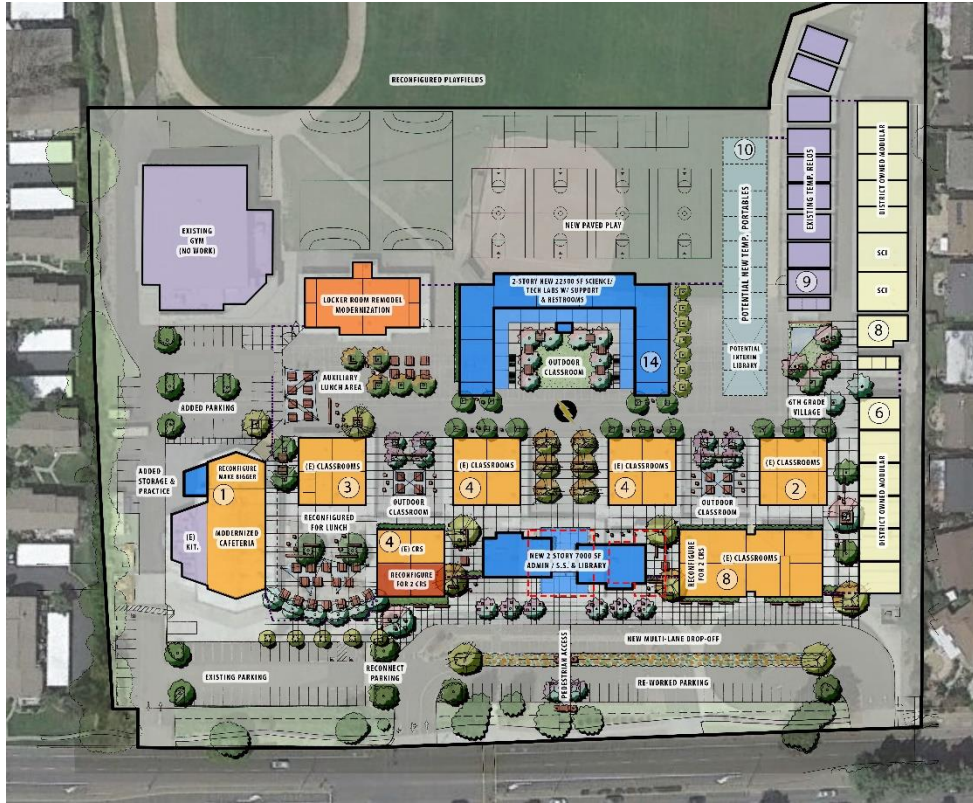
QKA Design Option 1

- Existing Building (No Current Work)
- New Construction
- Reconfigured / Major Modernization
- Moderate Modernization
- Minor Modernization
- Very Minor Modernization
- Demolish Building
- Potential New Temporary Portables
- Reconfigured Playfield

Housed in Existing Permanent Structures	1,194
Housed in Existing Temporary Portables	271
Housed in New Permanent Structures	454
Total Capacity (Meets LRFP Population Trends)	1,919
Capacity Based on Current Enrollment Projections	2,176 *
Unmet Capacity	(257)

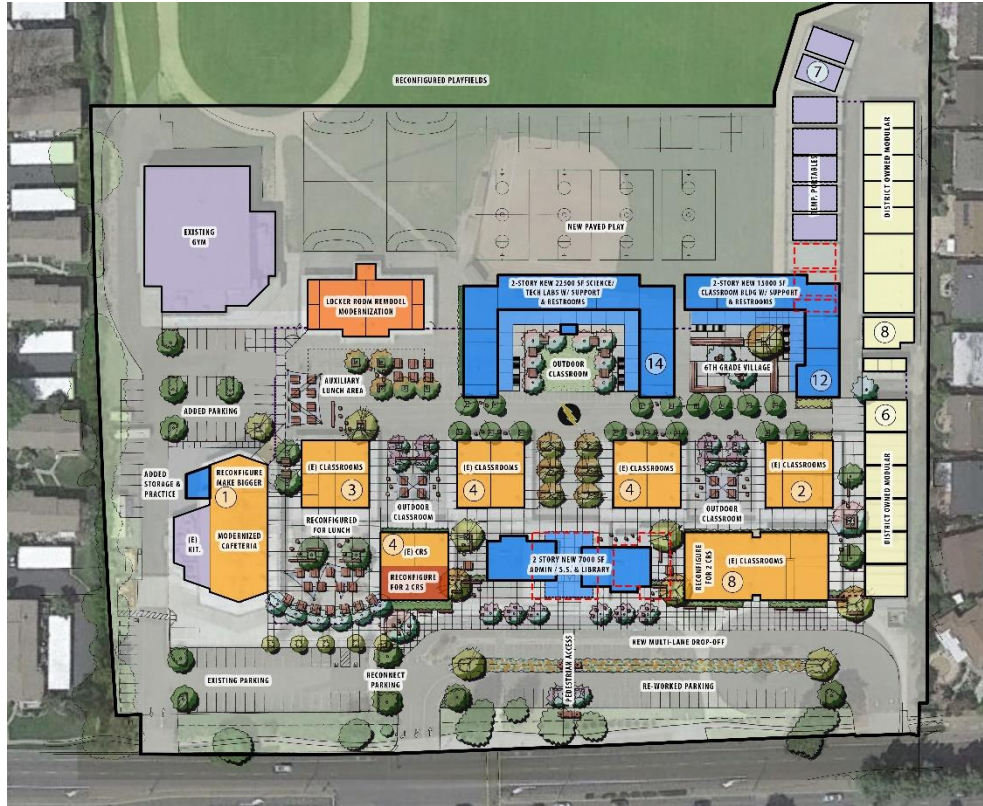
QKA Design Option 2B (Option 1 + More New Classrooms)

- Existing Building (No Current Work)
- New Construction
- Reconfigured / Major Modernization
- Moderate Modernization
- Minor Modernization
- Very Minor Modernization
- Demolish Building
- Potential New Temporary Portables
- Reconfigured Playfield

Housed in Existing Permanent Structures	1,194
Housed in Existing Temporary Portables	180
Housed in New Permanent Structures	802
Total Capacity (Meets LRFP Population Trends)	2,176
Capacity Based on Current Enrollment Projections	2,176
Unmet Capacity	0

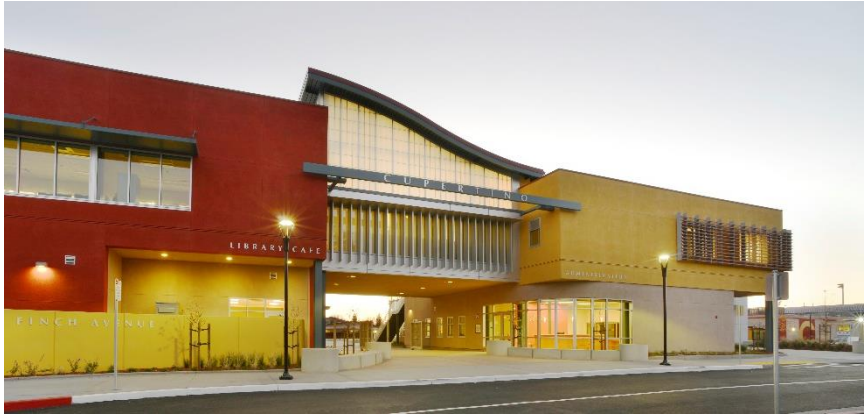
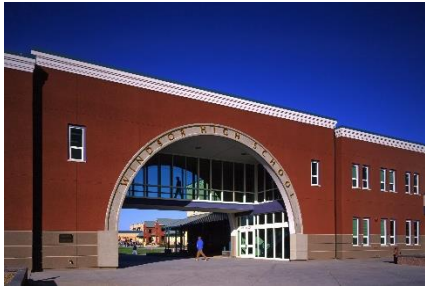
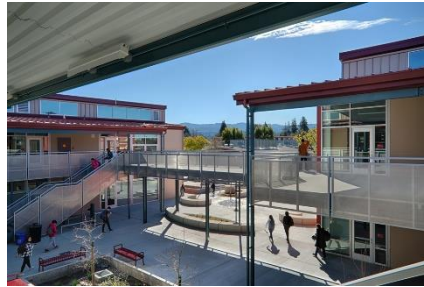
Possibilities – New Buildings

- New buildings have revitalized other campuses and will transform Thornton
- New entry provides focal point when approaching campus and more security options
- Revitalizes neighborhood and shows residents' tax dollars at work
- Modern science/technology classroom buildings promote 21-century learning

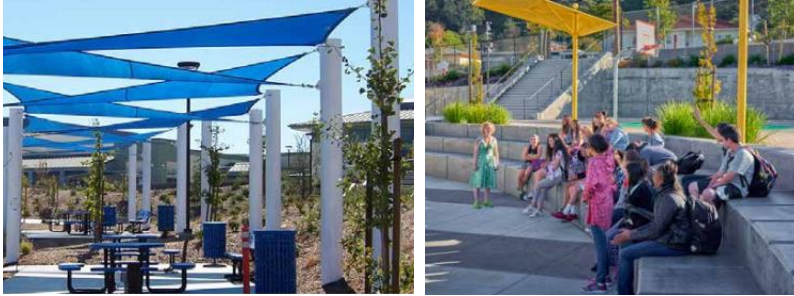
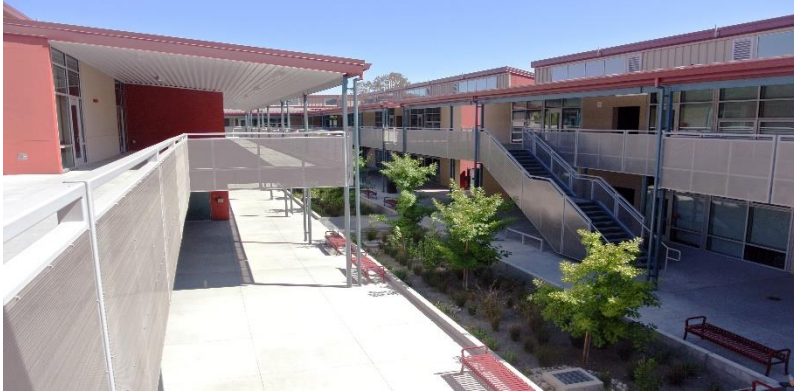
Possibilities – Landscape

- Designed outdoor spaces support 21st-century education goals
- Shaded areas for lunch, learning, PE
- Variety of scales promotes community and shapes individual identities
- Sustainable bioswales/planting areas improve drainage, cool microclimate
